# Technical Service Bulletin 910

## Improper Level of Mixed Bed Column

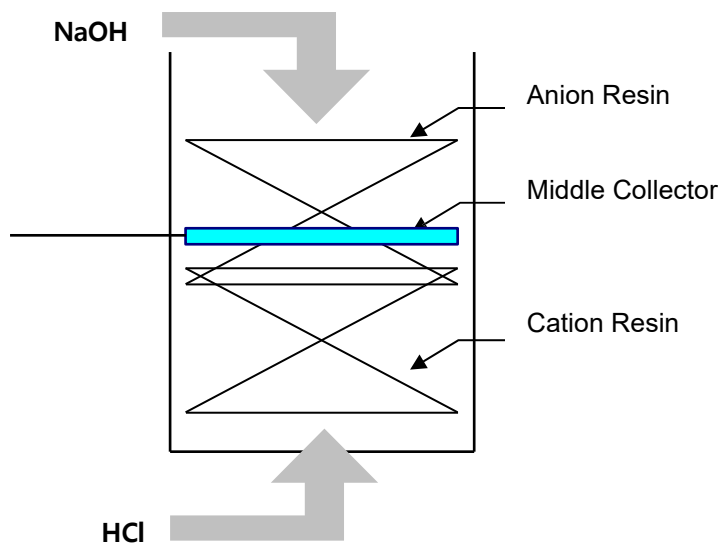
### 1. Problems When the Cation Exchange Resin Is Undercharged in the Mixed-bed Column

If cation resin is under-charged, there will likely be some anion resin below the middle collector level. During the regeneration process, the anion exchange resin below the middle collector comes into contact with HCl and converts to the Cl<sup>-</sup> form (a), which leads to a deterioration in water quality, during the service operation, due to the leakage of Cl<sup>-</sup> ions (b).

Due to the risks mentioned above, it is advisable not to perform partial replacement of the mixed-bed column but to do a full replacement or continue using it as is.

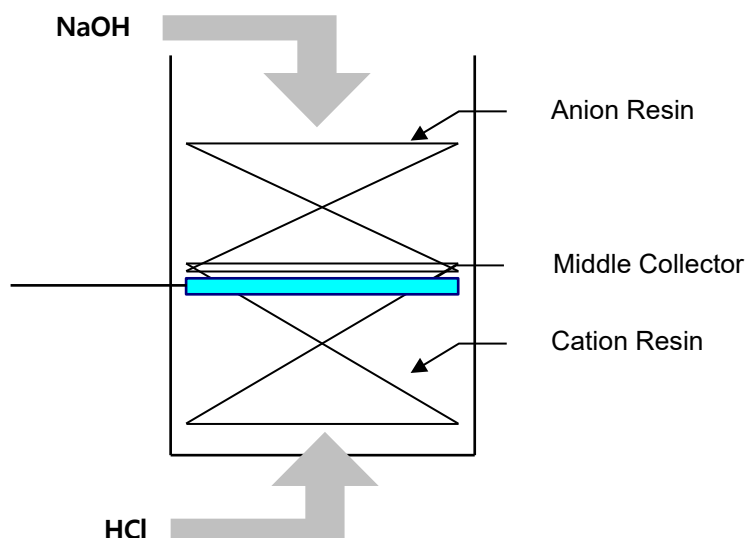
### 2. Problems When the Cation Exchange Resin Is Overcharged in the Mixed-bed Column

If cation resin is over-charged, there will likely be some cation resin above the middle collector level. During the regeneration process, the cation exchange resin above the middle collector comes into contact with NaOH and converts to the Na-form (a), which leads to a deterioration in water quality during the service operation due to the leakage of Na<sup>+</sup> ions (b).
