LG QuantumPure™ IX Resins

# Technical Service Bulletin 910

## Improper Level of Mixed Bed Column

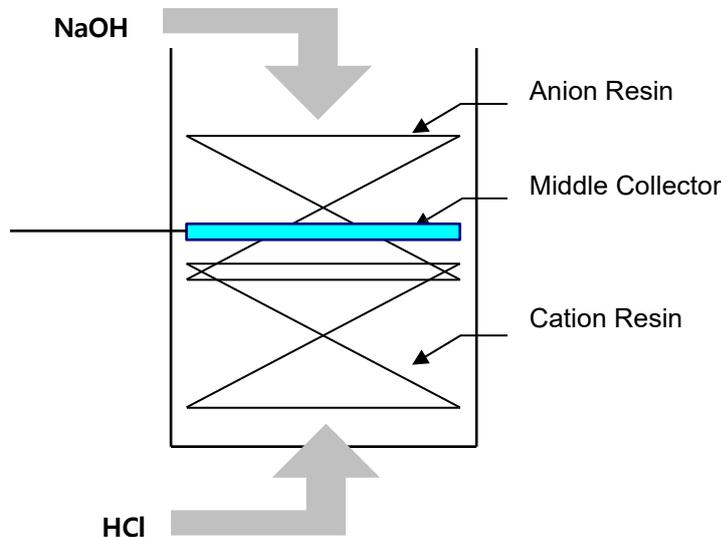
### 1. Problems When the Cation Exchange Resin Is Undercharged in the Mixed-bed Column

If cation resin is under-charged, there will likely be some anion resin below the middle collector level. During the regeneration process, the anion exchange resin below the middle collector comes into contact with HCl and converts to the Cl<sup>-</sup> form (a), which leads to a deterioration in water quality, during the service operation, due to the leakage of Cl<sup>-</sup> ions (b).

Due to the risks mentioned above, it is advisable not to perform partial replacement of the mixed-bed column but to do a full replacement or continue using it as is.

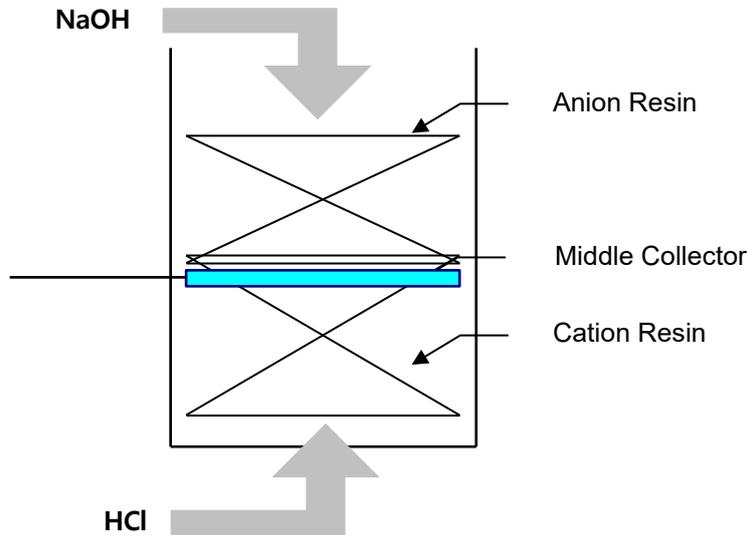
### 2. Problems When the Cation Exchange Resin Is Overcharged in the Mixed-bed Column

If cation resin is over-charged, there will likely be some cation resin above the middle collector level. During the regeneration process, the cation exchange resin above the middle collector comes into contact with NaOH and converts to the Na-form (a), which leads to a deterioration in water quality during the service operation due to the leakage of Na<sup>+</sup> ions (b).
